Situation as of 06/10/2026 10:46 UTC  
Delineation MONIT01 - Overview map 01

**Event:** On 01 October 2026, a severe rainfall and flooding event was reported to have affected Crete, Greece. The event is ongoing and increasing, with damage reported to affect buildings, critical infrastructure, transportation networks, agricultural areas and private properties. Copernicus EMS Rapid Mapping is requested to provide flood extent and damage assessment emergency mapping.

**Situation as of 06/10/2026 10:46 UTC**  
Delineation MONIT01 - Detail map 02

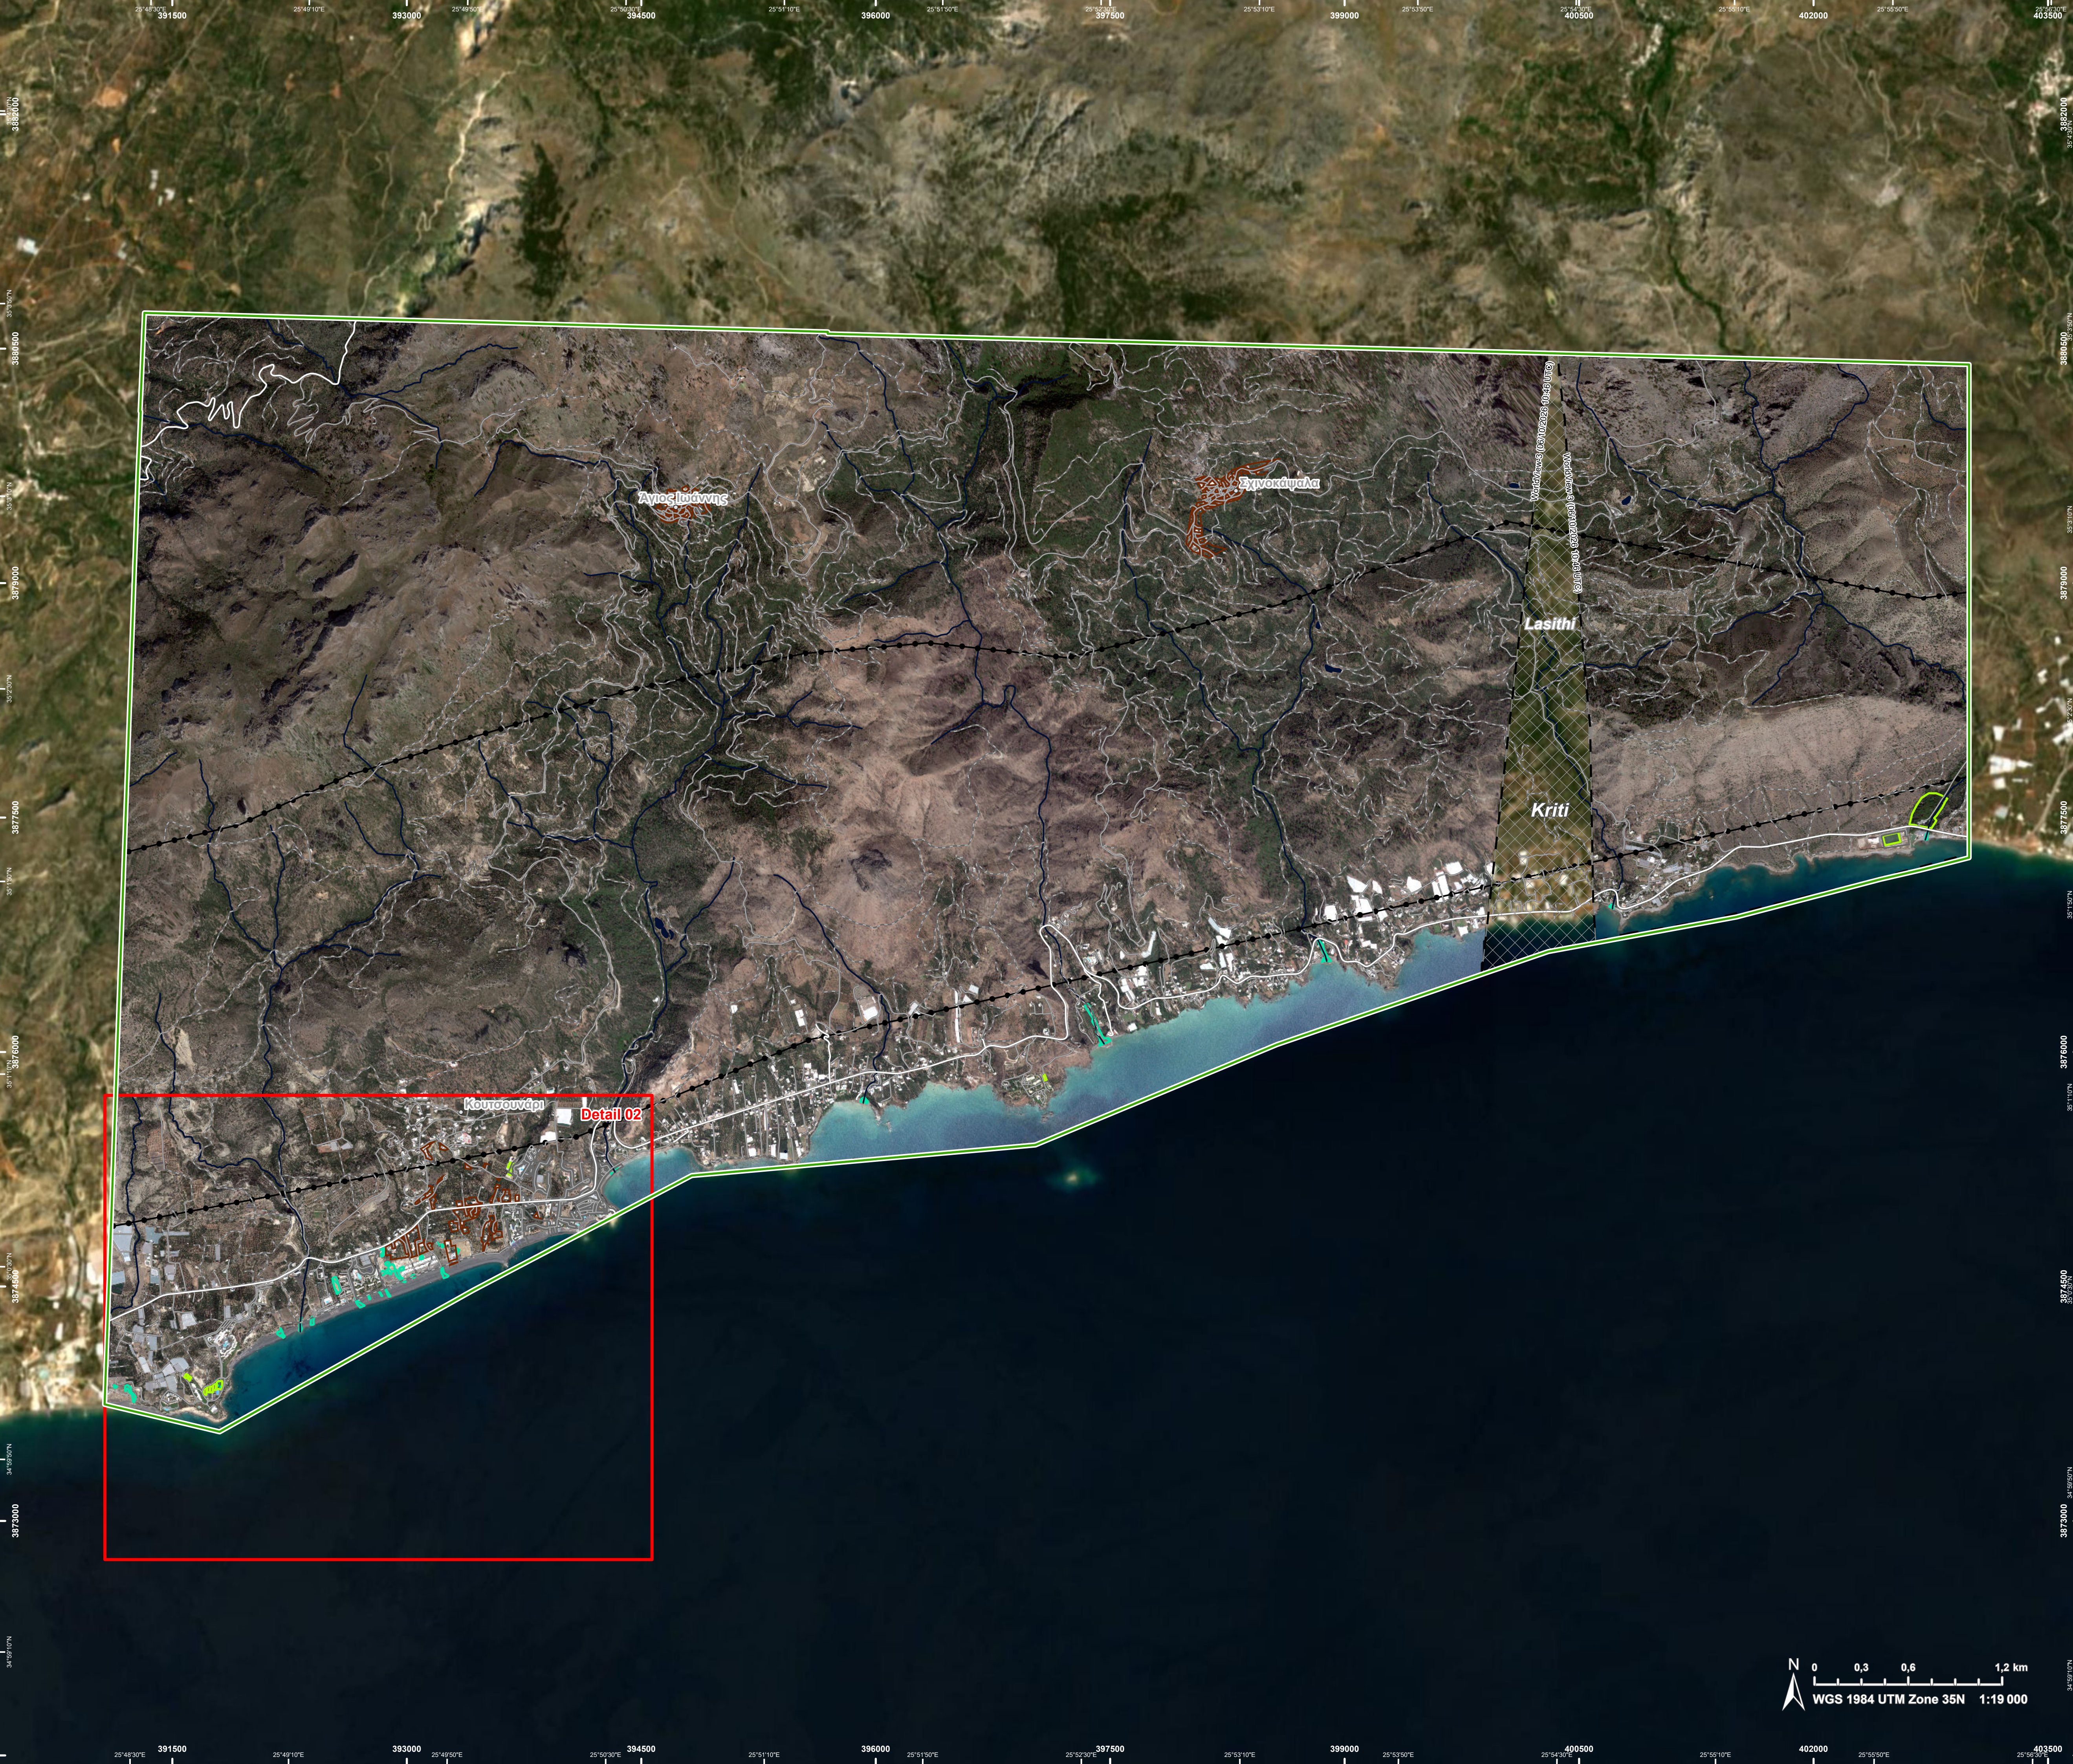
The thematic layer has been derived from post-event satellite image by means of visual interpretation.
