# Mandra - GREECE

## Flood - Situation as of 20/11/2017

### Grading Map

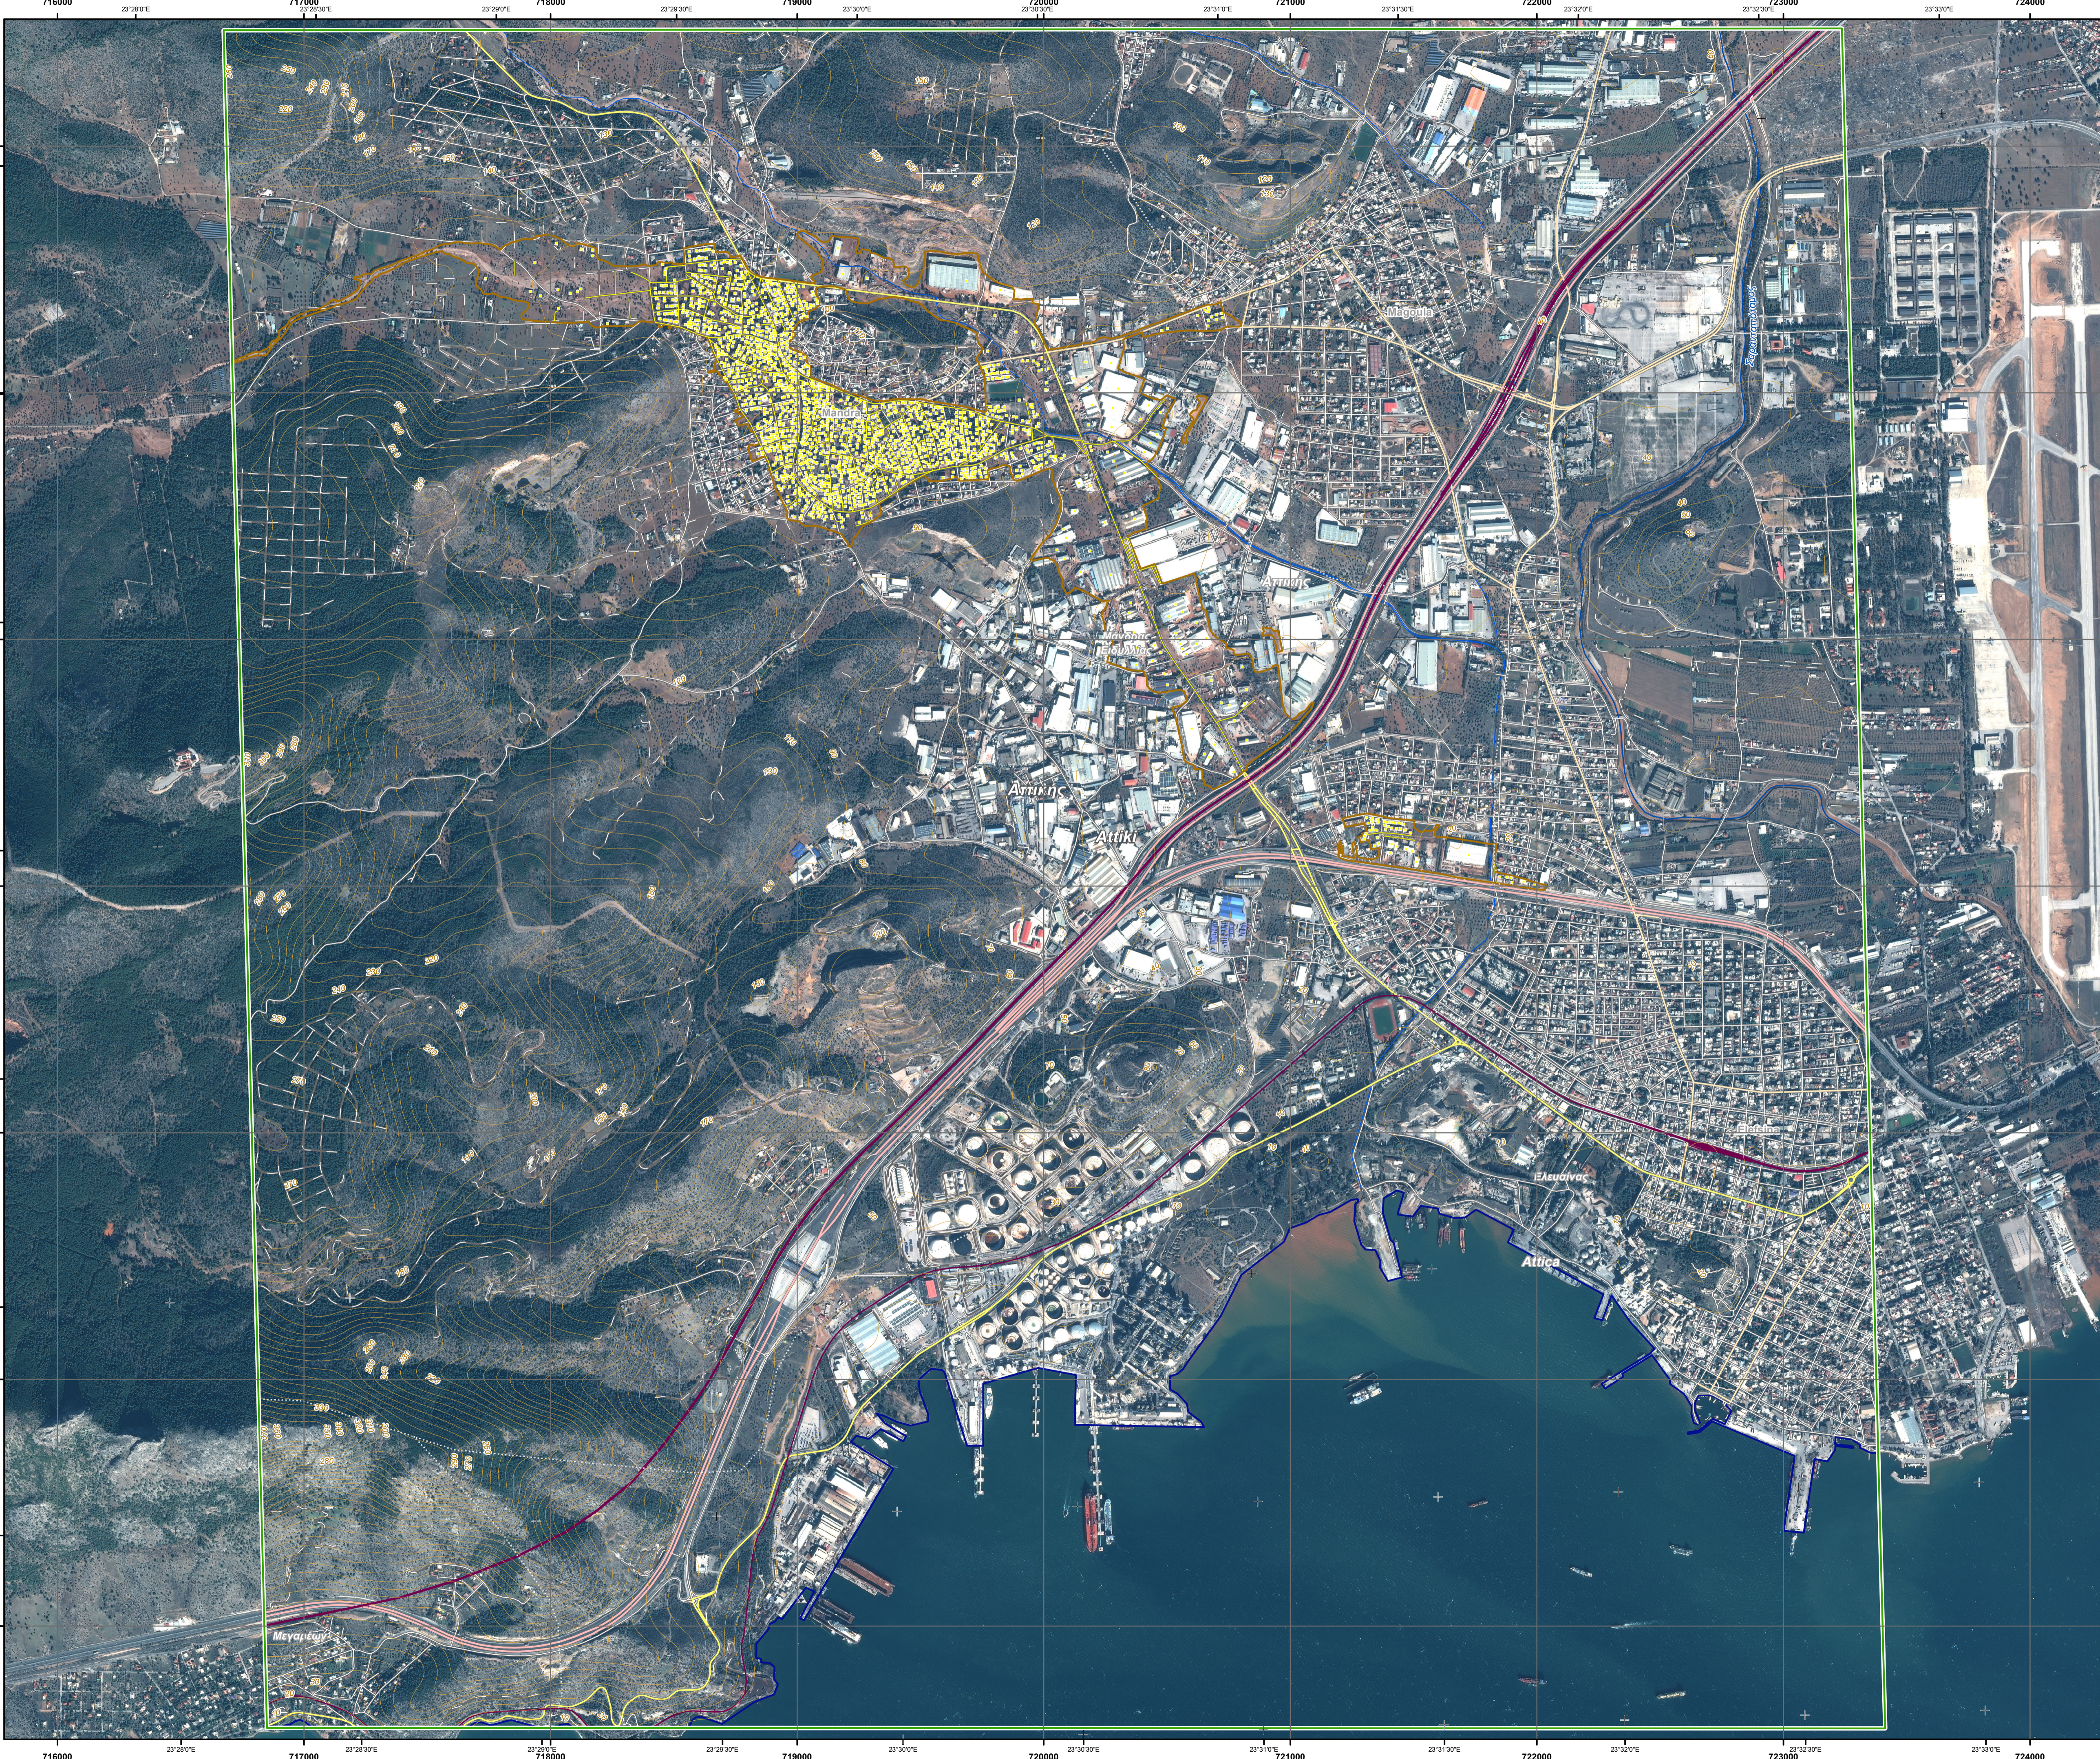
Consequences within the AOI						
	Unit of measurement	Destroyed	Damaged	Possibly damaged	Total affected	Total in AOI
Mudflow	ha				208.23	
Estimated population	No of people				6701	41045
Settlements	Residential	No	0	0	1869	1869
	Hotel buildings	No	0	0	1	1
	Wholesale and retail trade buildings	No	0	0	15	15
	Communication buildings, stations, terminals	No	0	0	2	2
	Industrial buildings and warehouses	No	0	0	69	69
	Public entertainment buildings	No	0	0	1	1
	Buildings used as places of worship	No	0	0	2	2
Cemetery	No	0	0	2	2	
Transportation	Highway	km	0	0	0	26.90
	Primary Road	km	0	0	1.69	1.69
	Secondary Road	km	0	0	1.65	1.65
	Local Road	km	0	0	17.12	17.12
	Cart Track	km	0	0	1.15	1.15
	Urban Railway	km	0	0	0	31.60

Flash floods in the areas of Mandra and Nea Peramos (Athens's western outskirts) that started on Wednesday 15-11-2017 early morning, turned roads into raging torrents of mud and debris, killing at least 20 people, inundating homes and disrupting the road network including several sections of the Athens-Korinthos highway. The General Secretary for Civil Protection has declared the area in State of Emergency.

The present map shows the damage grade assessment in the area of Mandra (Greece). The thematic layer has been derived from post-event satellite image by means of visual interpretation. The estimated geometric accuracy is 5 m CE90 or better, from naive positional accuracy of the background satellite image.
