Orestiada - GREECE Flood - Situation as of 27/03/2018 Delineation Map

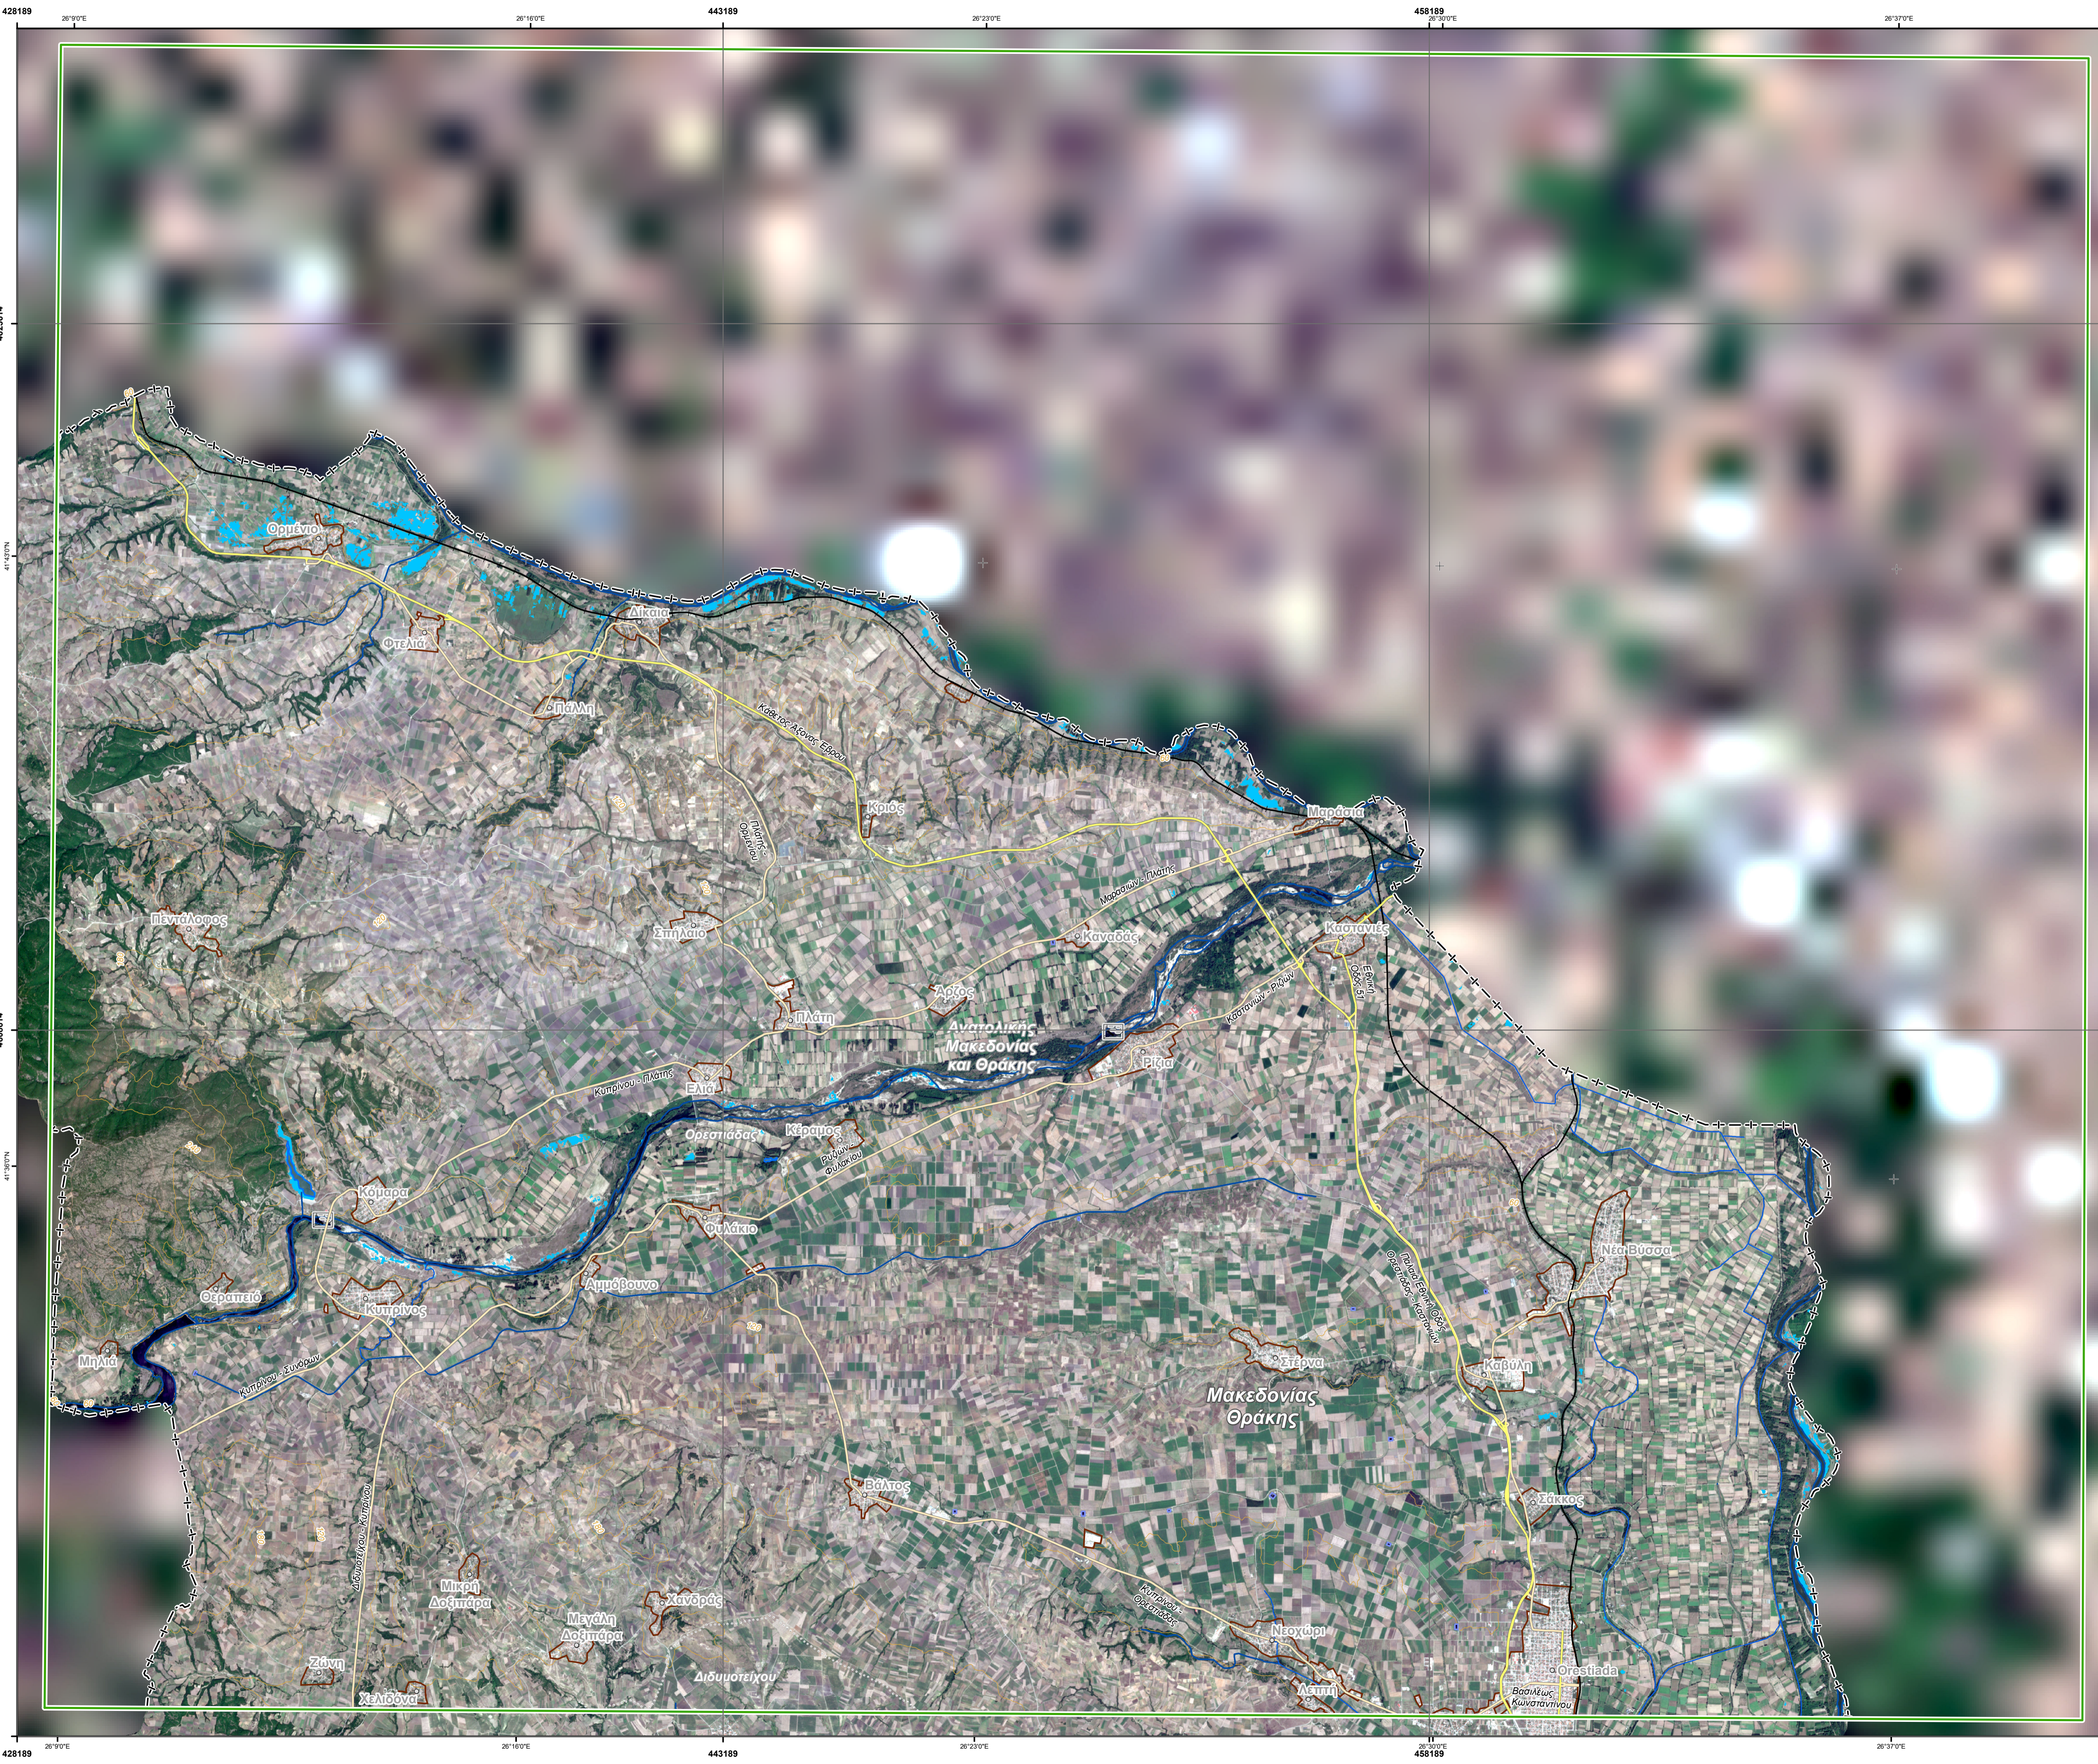
Map Information
 Due to extensive rainfall and snow-melt of the last few days, and also due to large amounts of water that was released from dams in rivers Evros and Arda, many areas of Evros Regional Unit have been flooded. Extensive damages are reported in agricultural land, road and railway network. Many embankments across Evros river, broke, causing further problems. The Regional Unit of Evros has been declared in a state of emergency.
 The present map shows the flood delineation in the area of Orestiada (Greece). The thematic layer has been derived from post-event satellite image using a semi-automatic approach. The estimated geometric accuracy is 5 m CE90 or better, from native positional accuracy of the background satellite image.

Unit of measurement	Affected	Total in AOI
Flooded area	ha	0	378.1
Estimated population	Number of inhabitants	0	200405
Settlements	Residential	ha	0.0 2049.3
Transportation	Primary Road	km	0.0 67.1
	Secondary Road	km	0.0 130.3
	Long-distance railway	km	0.0 57.2
Facilities	Dam	No.	0 2
