GLIDE number: N/A      Activation ID: EMSR277  
Product N.: 03FERES, v1, English

## Feres - GREECE

### Flood - Situation as of 01/04/2018

#### Delineation Map - MONIT01

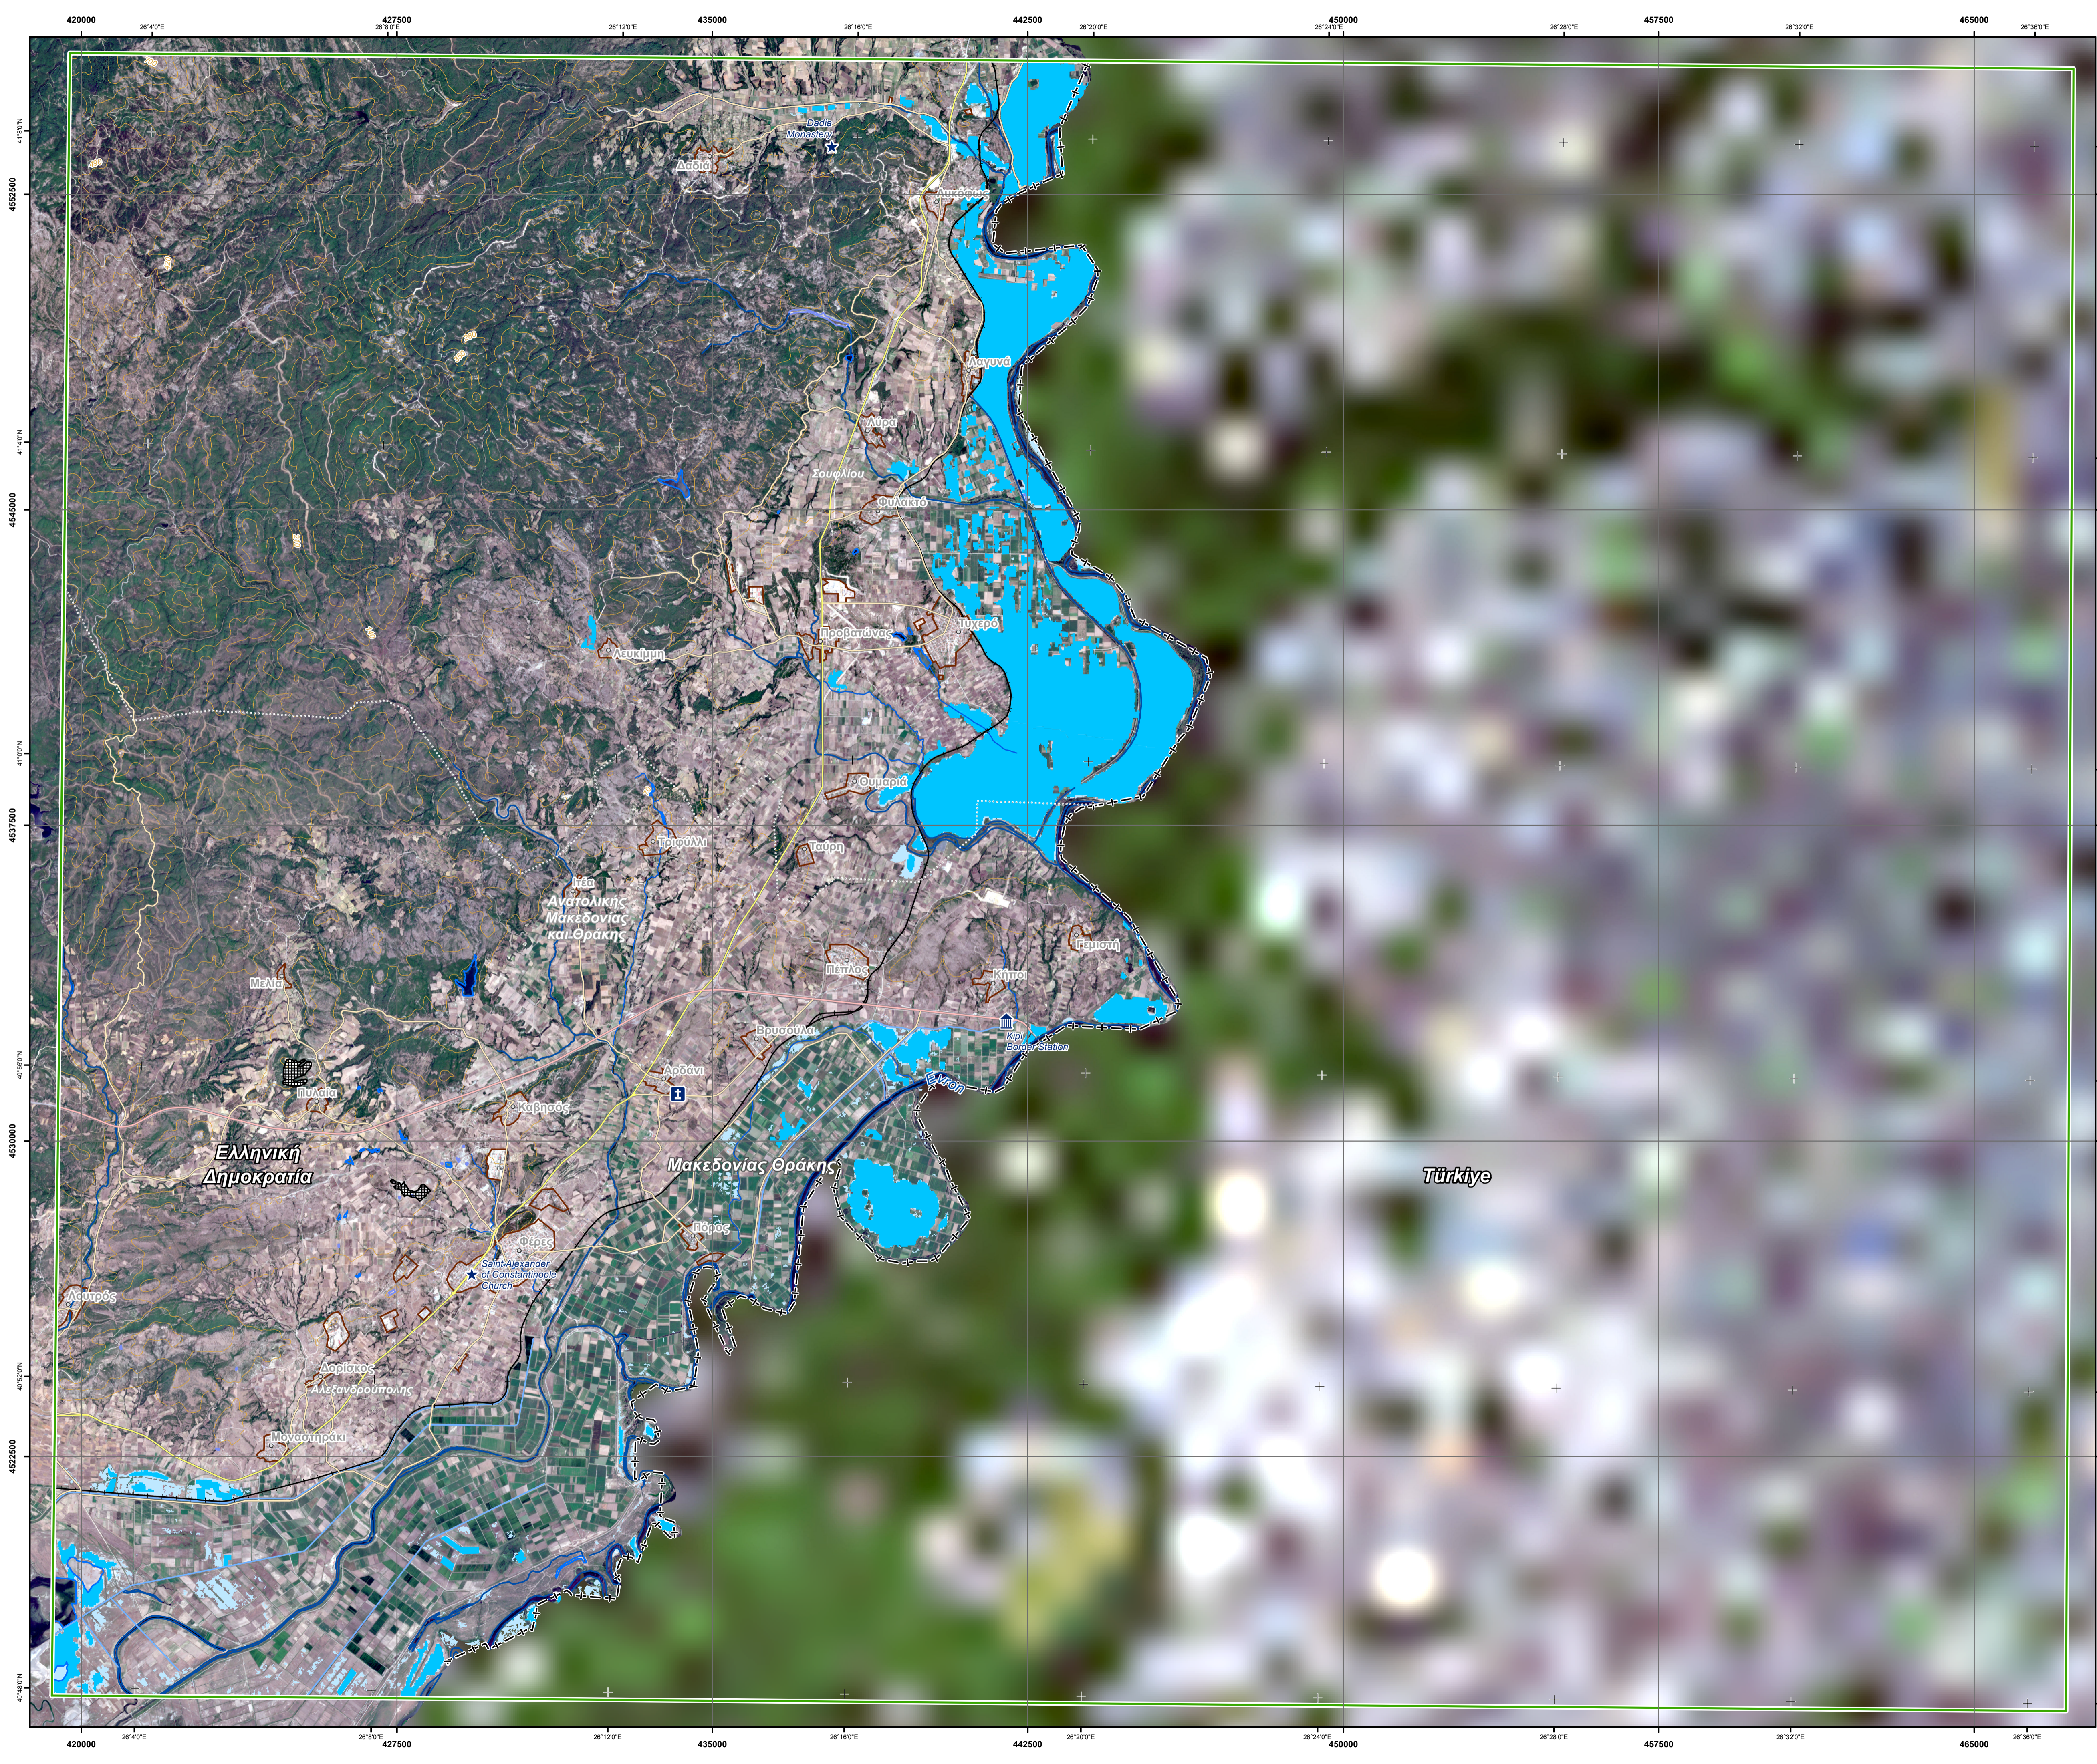
Due to extensive rainfall and snow-melt of the last few days, and also due to large amounts of water that was released from dams in rivers Evros and Ardas, many areas of Evros Regional Unit have been flooded. Extensive damages are reported in agricultural land, road and railway network. Many embankments across Evros river, broke, causing further problems. The Regional Unit of Evros has been declared in a state of emergency.

The present map shows the flood delineation in the area of Feres (Greece). The thematic layer has been derived from post-event satellite image using a semi-automatic approach. The estimated geometric accuracy is 5 m CE90 or better, from native positional accuracy of the background satellite image.

Consequences within the AOI				
		Unit of measurement	Affected	Total in AOI
Flooded area		ha	0	4988.5
Estimated population		Number of inhabitants	0	94644
Transportation	Residential	ha	0.0	1190.6
	Highway	km	0.0	25.1
	Primary Road	km	0.0	48.2
	Secondary Road	km	1.5	179.8
Facilities	Long-distance railway	km	0.7	55.0
	Navigable canal	km	0.0	50.3
	Construction for mining or extraction	ha	0.0	45.8
