Karla Lake - GREECE

Flood - 18/12/2023

P04 - Flood Delineation

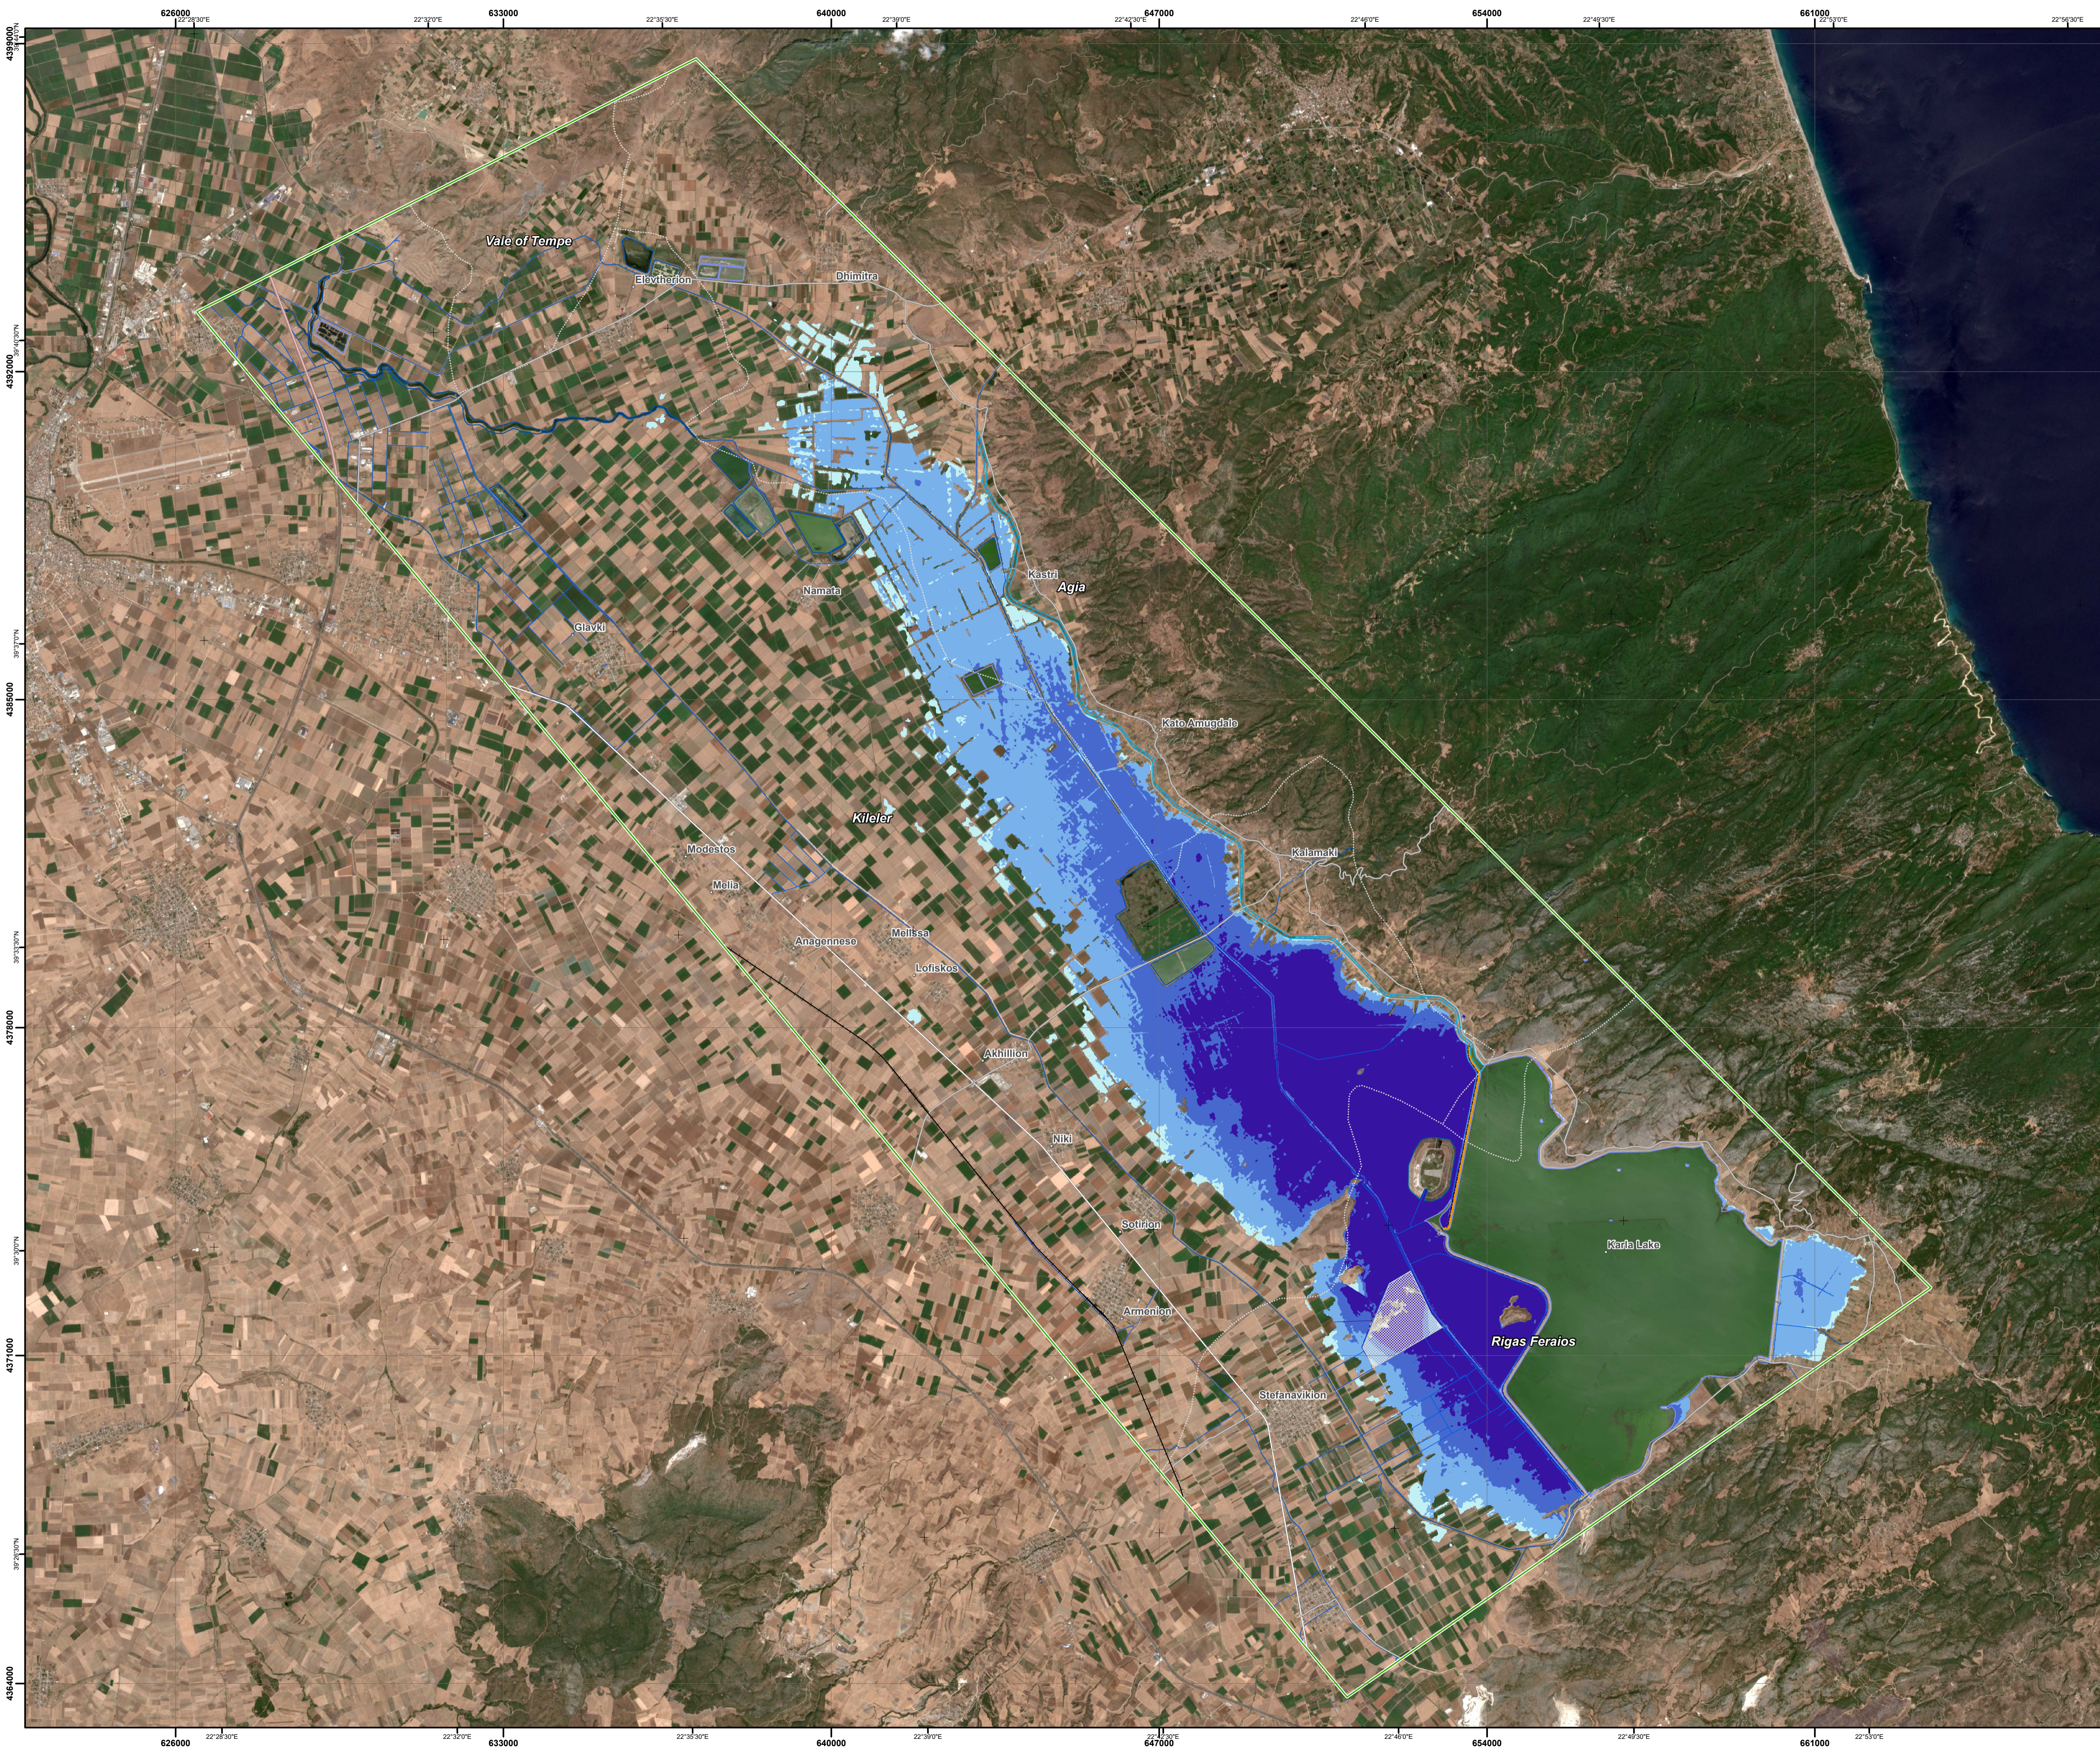
The present map shows the flood extent and water depth in the area of Karla Lake (Greece). The thematic layer has been derived from post-event satellite image by semi-automatic approach.

The calculated geometric accuracy (RMSE) is 20 m or better, from native positional accuracy of the input satellite image.

This product is based on visual interpretation of recognizable items on very high resolution optical imagery. The assessed thematic accuracy value is 97.5%, assessed following the Quality Control methodology described in the Final Report (see <https://emergency.copernicus.eu/mapping/list-of-components/EMSN184>).

Consequences within the AOI		Unit of measurement	Total	Total in AOI
Flooded area		km ²	9815.88	9815.88
Estimated population		Number of inhabitants	~650	~8900
Transportation	Roads	km	178.49	1361
	Railways	km	0.00	18
	Airfields	ha	152.90	176.20
Facilities	Sport and recreation constructions	ha	0.00	12.92
	Dams	ha	4.23	24.35
	Constructions for mining or extraction	ha	0.00	8.51
	Power plant constructions	ha	6.21	77.00

In September 2023, Thessaly Region, Greece, was hit by extended floods due to heavy rainfall. After three months, an area north-west of Karla lake is still flooded. The CEMS Risk and Recovery Standard has been activated to get a delineation product of the flooded area for the planning of the necessary recovery measures.
