Mouzaki - GREECE

Flood - Situation as of 24/09/2020

Grading - Overview map 01

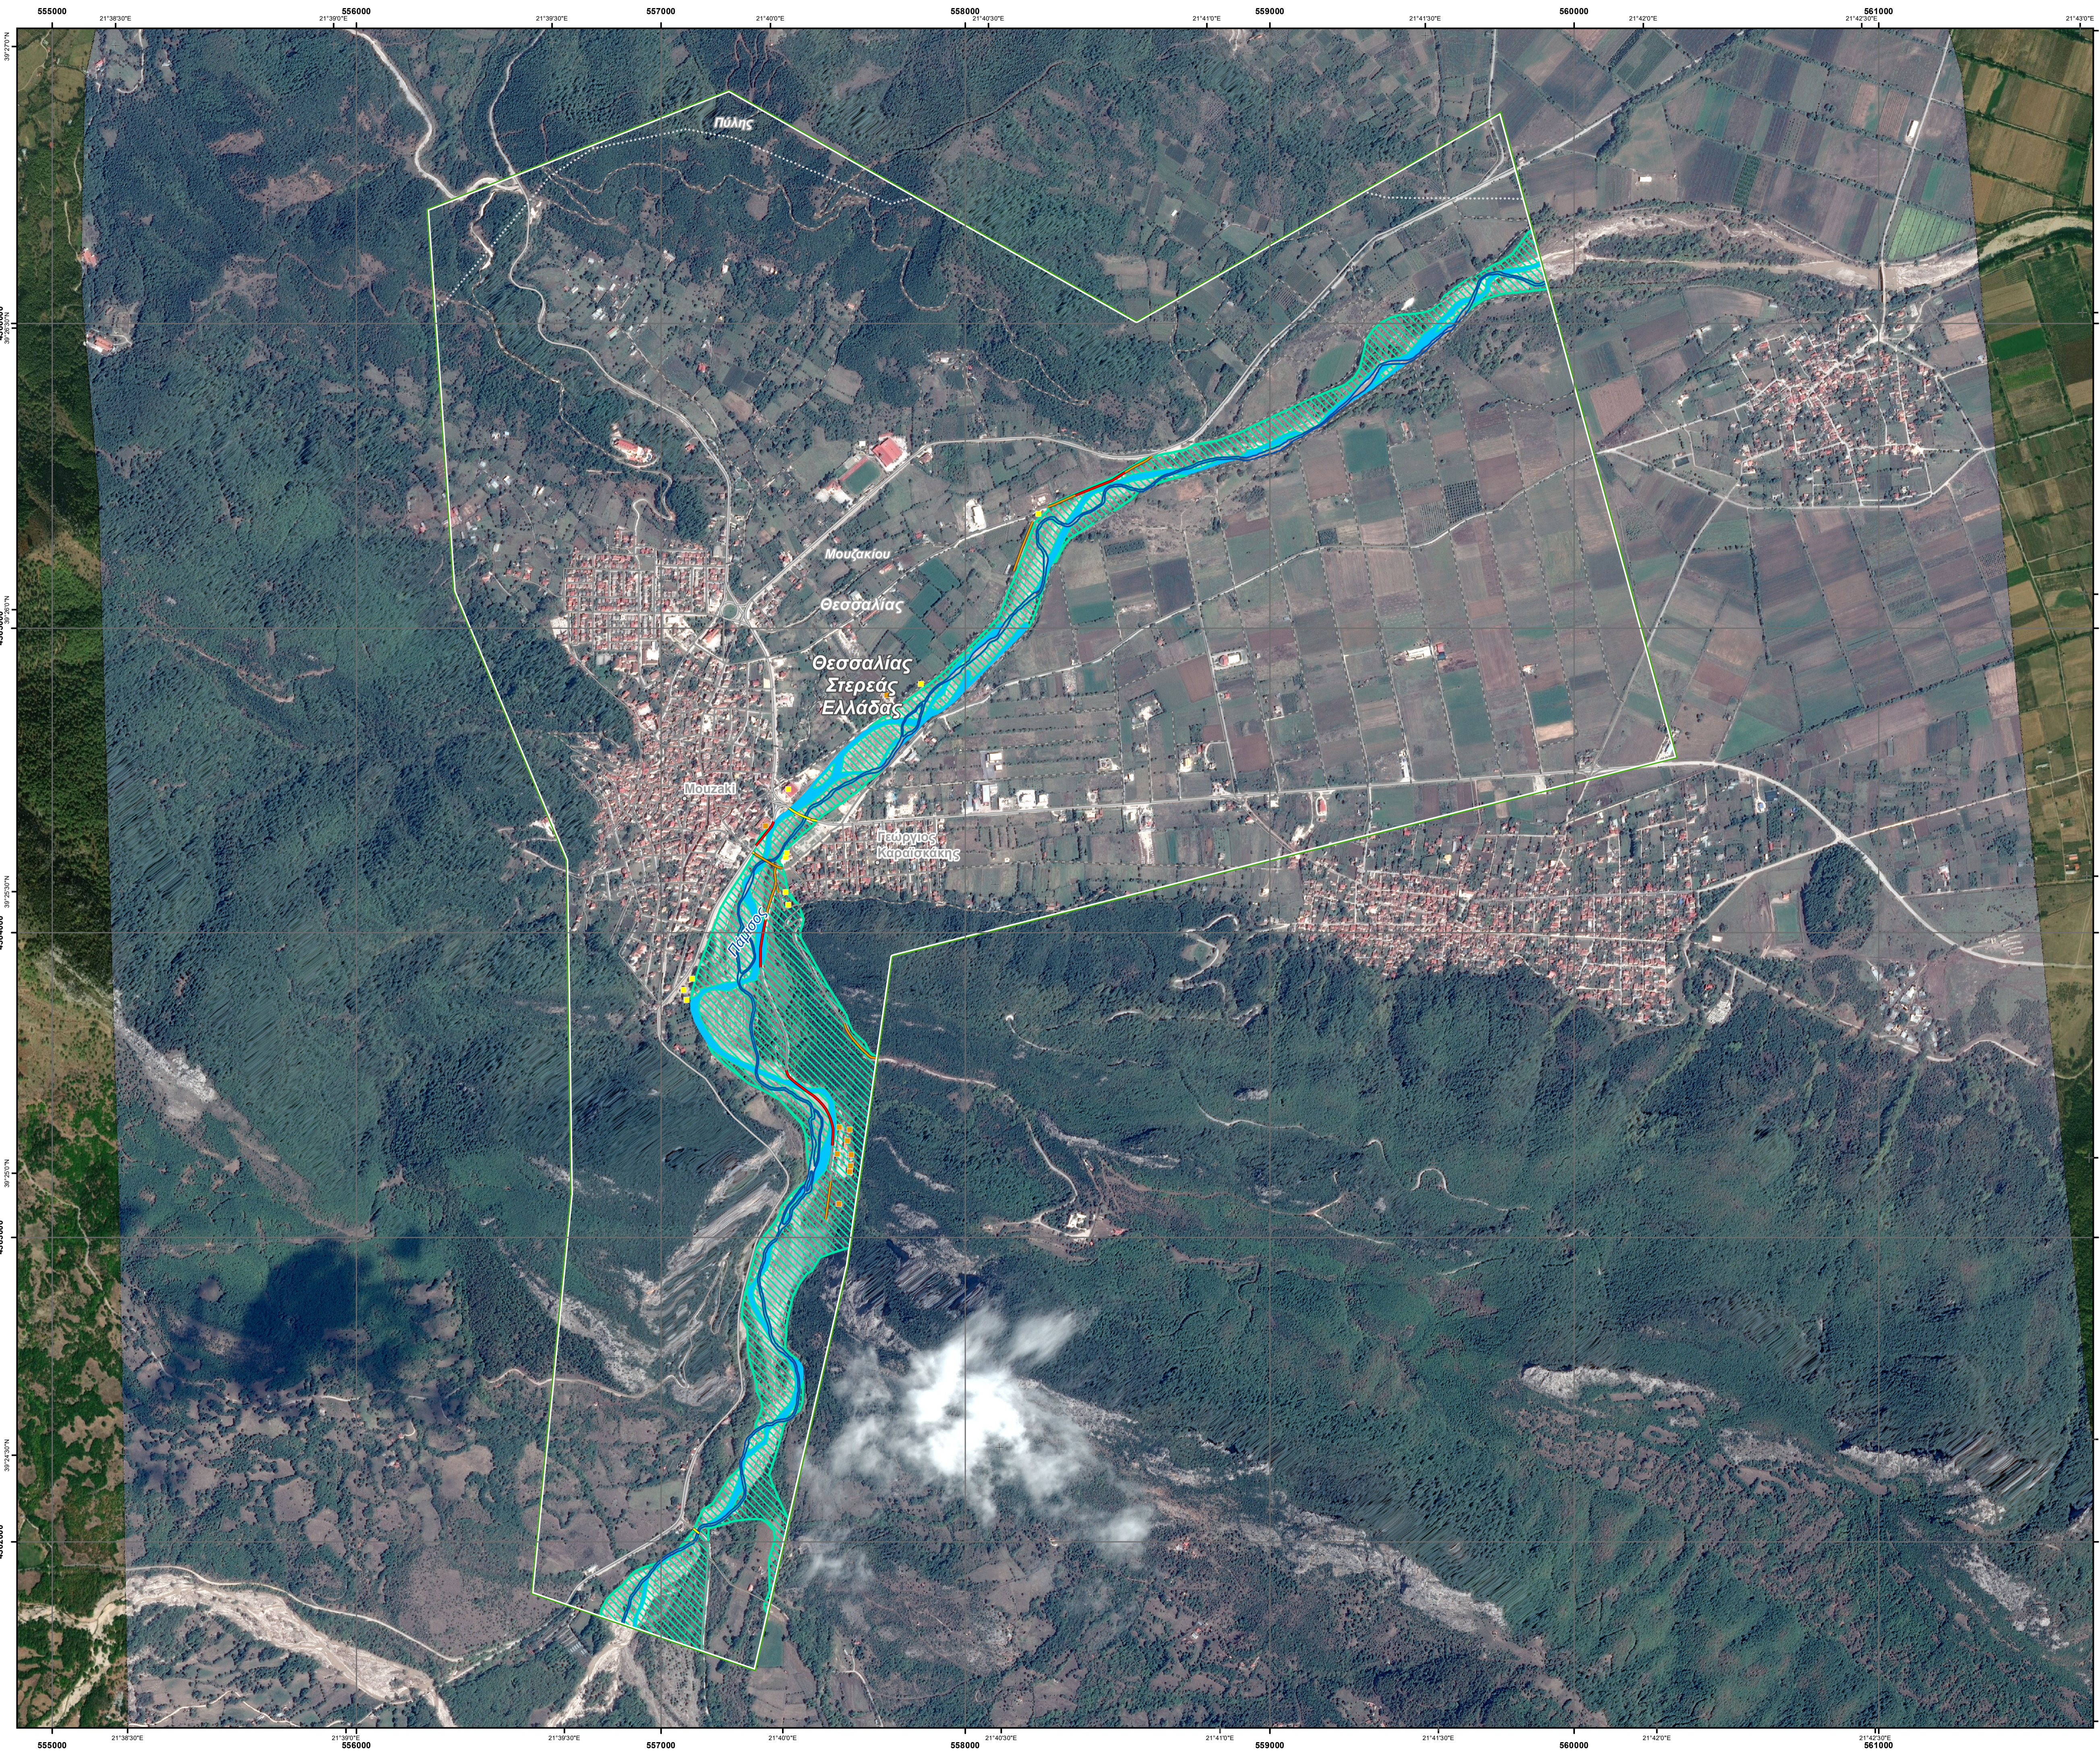
Consequences within the AOI		Unit of measurement		Destroyed	Damaged	Possibly damaged	Total affected	Total in AOI
Flooded area	km ²	0	1	1	1	1	3	10
Flood trace	km	0	1	1	1	1	3	22.3
Number of inhabitants		0	1	1	1	1	3	272
Settlements	Residential Buildings	No	0	0	10	19	29	NA
	Hospital or recreational care buildings	No	0	0	0	0	0	NA
Transportation	Secondary Road	km	0.1	0.0	0.1	0.2	0.4	NA
	Local Road	km	0.0	0.0	0.0	0.0	0.0	NA
	Cart Track	km	0.0	0.0	0.0	0.0	0.0	NA

The present map shows the damage grade assessment in the area of Mouzaki (Greece). The thematic layer has been derived from post-event satellite image by means of visual interpretation. The estimated geometric accuracy (RMSE) is 1.25 m or better, from native positional accuracy of the background satellite image.
